Analysis of Gas Pipeline Failure

E. Phillip Dahlberg and T. V. Bruno

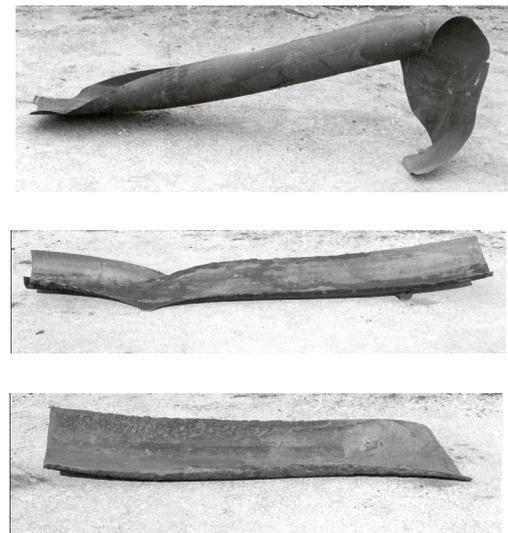
Figure 2. Rupture sections of 8-5/8 inch gas pipeline that failed due to external mechanical damage.

Figure 2 shows the rupture that developed in a section of 8-5/8 inch O.D. electric-resistance line pipe. Visual and metallographic examination revealed the failure was caused by mechanical damage, in the form of a gouge and dent, often associated with heavy equipment such as a back-hoe. Figure 3 shows a detail of a gouge that was near the midpoint of the rupture. The profile of the gouge, shown in Figure 4, is a polished and etched cross section of matching fracture surfaces at the failure origin. The combination of a gouge and dent is particularly damaging. The gouge cold works the steel and reduces its resistance to crack initiation. The dent, by changing the geometry, creates an area of high stress and stress concentration.

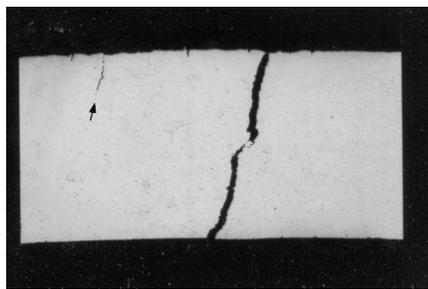
Figure 4. A cross section through the gouge Shows a dark etching area near the outside Surface with a small secondary crack (arrow) Near the fracture.

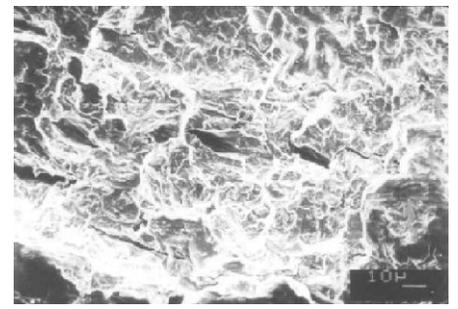
Figure 5. SEM fractograph of fatigue damage associated with the longitudinal weld seam of a 34-inch O.D. pipeline.

A second form of external damage can be introduced by fatigue cracking during pipe shipment, particularly in rail and sea shipment. The damage, sometimes called transit fatigue, results from flexing the pipe during load movement. Transit fatigue in seamless pipe and the base metal of welded pipe results from concentrated stresses where the pipe contacts a protrusion, such as a rivet or bolt, the weld of an adjacent pipe, or bearing strips of insufficient size. In submerged-arc welded pipe, transit fatigue cracks can develop at the toe of the weld even in the absence point contact. Figure 5 shows the fine ductile fatigue striations and secondary cracking that characterize transit fatigue damage.

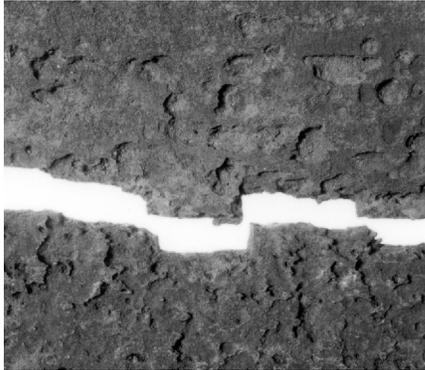
Figure 6. Inside surface at the failure origin of a 20-inch pipeline.

Corrosion can cause failures by thinning the wall over a large area or localized pitting. Both external and internal corrosion can lead to failures, but the widespread use of cathodic protection has greatly reduced external corrosion. Figure 6 shows the inside surface at the failure origin of a 20-inch gas line that failed shortly after the operating pressure was increased. The failure resulted from internal pitting corrosion on the bottom of the pipeline that significantly reduced its wall thickness. Figure 7 shows the depth of the pitting on a polished cross-section cut transverse to the fraction (arrow).

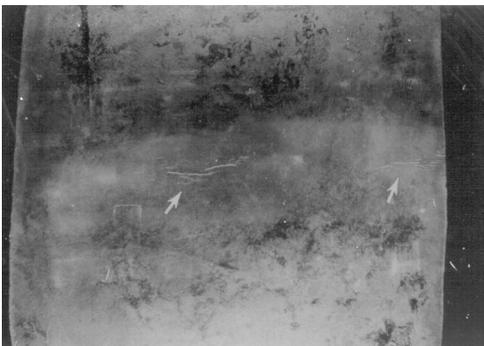
Figure 8. Outside surface of pipeline section removed because of a leak. The arrows indicate two clusters of crack indications visible after magnetic particle inspection.

External stress-corrosion cracking results from the accumulation of moisture on the pipe surface at imperfections in the pipe coating. Certain corrosives in the moisture in conjunction with normal operating stresses cause cracking. Stress corrosion cracking in pipelines is identified by the distinctive intergranular nature of the cracks. Figure 8 shows cracks in a section of pipe removed for examination because of a leak. The cracks resulted from stress-corrosion cracking. The surface of a crack, extending across the wall, was broken open in the laboratory and is shown in Figure 9. A metallographic cross-section, Figure 10, showed the cracks to be intergranular.

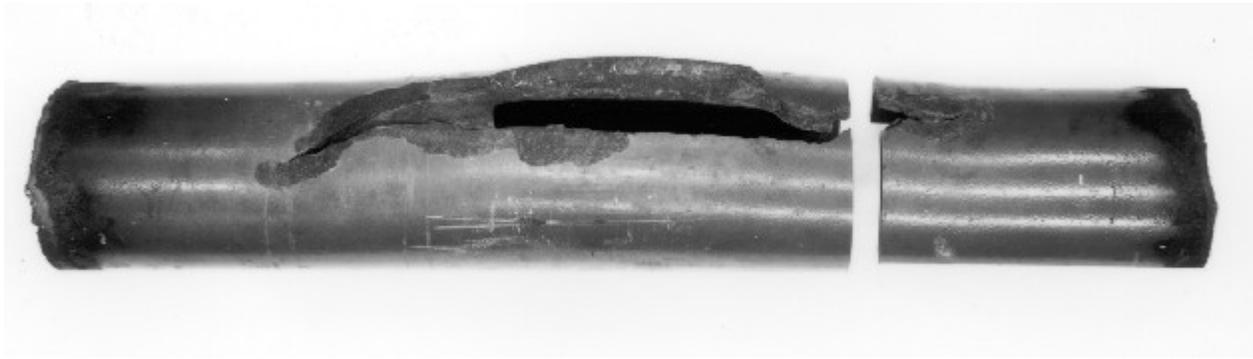
Figure 11. Hydrostatic test rupture of seamless 6-5/8 inch O.D. pipeline showing thin tongue of metal protruding from around a pipe lamination.

Material defects are not common causes of service failures because they are usually found before the pipe is placed in service, either during inspection of the pipe or during hydrostatic testing. The few failures that do result typically originate at longitudinal weld seams or at laminations in seamless pipe. Figure 11 shows the rupture of a 6-5/8 inch O.D. seamless pipeline that resulted from a pipe lamination. In this instance, failure occurred during hydrostatic testing.

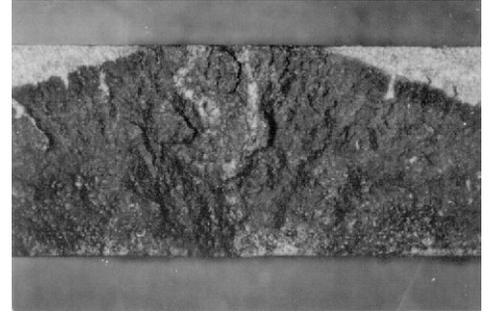
Figure 9. Surface of crack (see Figure 8) that was broken open in the laboratory. The inside surface is at the top.

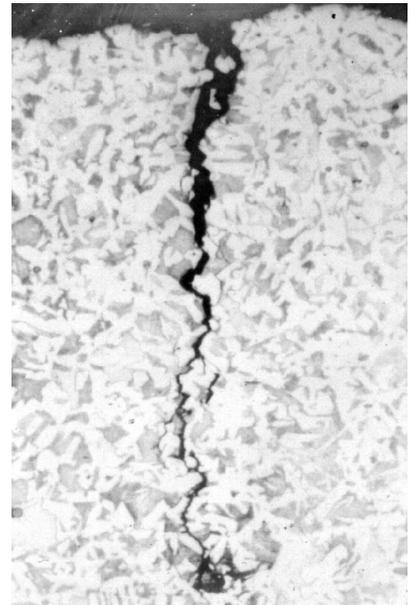
Figure 10. Microstructure in area of secondary crack showing an intergranular cracking mode.
