Analysis of Gas Pipeline Failure

E. Phillip Dahlberg and T. V. Bruno

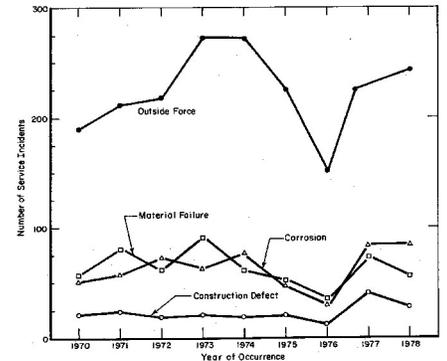
Figure 1. Number of gas pipeline service incidents versus year of occurrence by cause. (From Giedon, D.N. and R.B. Smith, "An Analysis of Reportable Incidents for Natural Gas Transmission and Gathering Lines 1970 through 1978," NG-18 Report No. 121, Sept. 1980.)

Over half of all in-service pipeline failures result from some externally applied mechanical force as shown in Figure 1. The following are examples of five typical failures.
